REDUCTION GEARBOX WITH BELZONA CHOCKS ON FISHING BOAT

Fishing Boat, Peru

September 2015

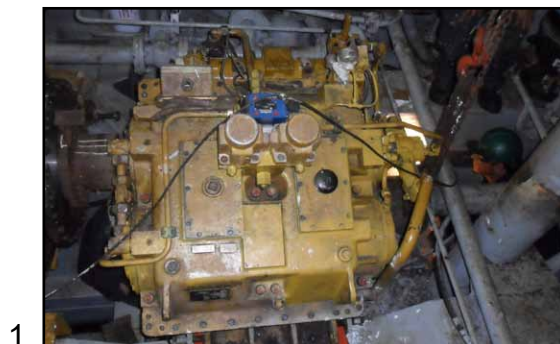
1. Naval propulsion reduction gearbox
2. Filling the dam by pouring
3. Exact adjustment with torque wrench
4. Completed project with minimum variation which does not affect alignment
