## BELZONA REPAIR KEEPS BELTS TRACKING

Metal Recycler, Tennessee, USA

August 2015

Conveyor belt.

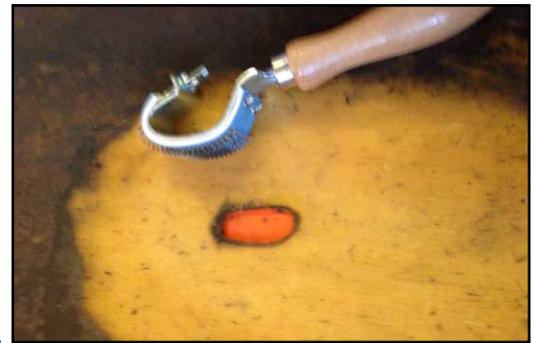
1. Application area cleaned and conditioned
2. Application in progress
3. Repair completed
4. Repair re-visited after 4 weeks of impact and abrasion from sharp, shredded metal

The application was carried out using a modified version of Belzona Know-How System Leaflet SHM-1. The surface was cleaned using a cleaner/degreaser and roughened using the Belzona roughing brush. The area to be repaired was then taped off and conditioned with Belzona 2911 and allowed to dry until touch-dry. Since the belt was only 1/8" thick and not multi layered, it was not possible to remove the top layer and insert the repair material to create a flush surface. Alternatively, a mixing board was used as a backer to the area to be repaired. The hole was filled and the substrate coated with Belzona 2311. Then, Belzona 9341 was embedded with Belzona 2311 and laid over the hole and topped with more Belzona 2311 so it would not leave the reinforcement sheet exposed. Two repairs were carried out in this manner as well as a smaller hole repair without the reinforcement sheet.
