## BELZONA CALLED IN FOR TOUGH FLOOR REPAIRS

Concrete floors.

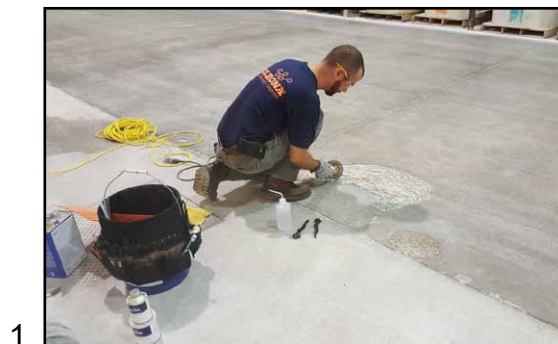
1. Preparing the area with a grinder
2. Conditioning with Belzona 4911
3. Applying Belzona 4111 by trowel
4. Completed application

The application was carried out in accordance with Belzona Know-How System Leaflet FPA-1. The repair area was cleaned using acetone and a rotary wire wheel. An angle grinder was then used with a masonry wheel to prepare the area to allow for an application of at least 1/4" of Belzona 4111. The area was then given a final cleaning with acetone. Belzona 4911 was used to condition the substrate and Belzona 4111 was then trowelled into place and smoothed out. In the warm environment the repair was ready for service in about 4 hours.
