## BELZONA STOPS LIVE AIR HANDLER LEAK

Hospital, Nashville, TN, USA

Leaking air handler condensate pan.

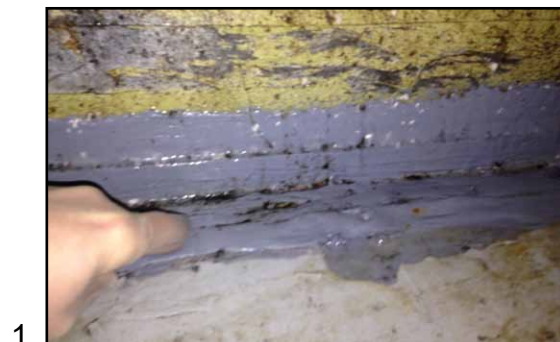
The air handler condensate pan was leaking water. Corrosion had allowed for water to push underneath the pan and out between the pan and concrete pedestal. This was the result of a previously applied competitor's coating in the pan and around the bottom seam disbonding.

1. Old coating disbonded, notice the bubble pushing through when the material was pressed on
2. Bad portion of old coating removed, prepped with wire brush and wiped with acetone
3. Application of Belzona 3121 in progress
4. Completed application
