STRIPPED THREADS QUICKLY REPAIRED WITH BELZONA

Stripped threads on a Caterpillar 990 Final Drive were leaking oil.

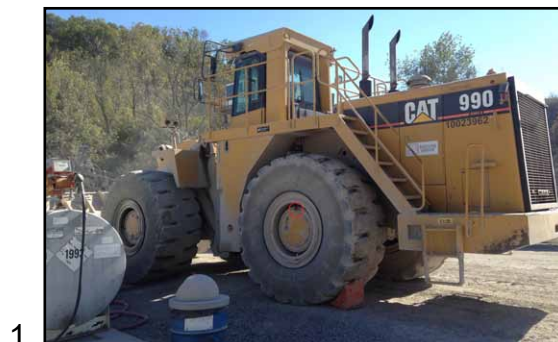
The oil plug on a Caterpillar 990 Final Drive, had been stripped when someone used an impact wrench instead of hand tightening the bolt. The customer was faced with downtime of the equipment and expensive new parts.

1. Cat 990 with leaking oil evident
2. Bolt cavity prepared for application
3. Applying Belzona 1212 to threads on bolt and bolt cavity
4. Completed application, bolt snugged down and waiting to go back into service
