## BELZONA ELASTOMER SEALS A TRANSFORMER'S BUSHING

Electricity Substation, USA

Transformer bushing adaptor

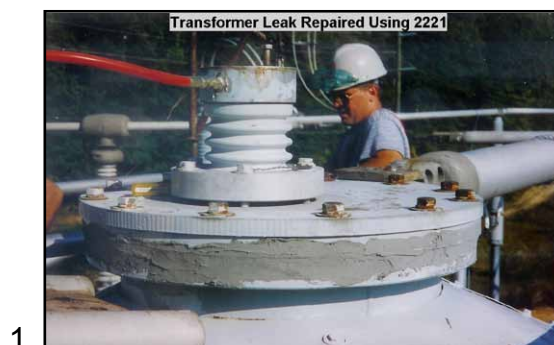
1. View of the transformer
2. Belzona 2221 poured into a fabricated mold
3. Bushing completely sealed with Belzona 2221

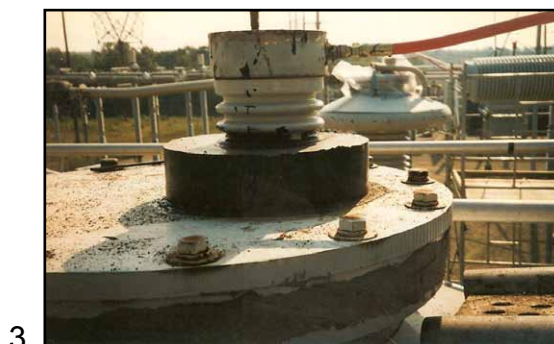
The bushing no longer sealed and it was allowing freon gas to escape.

The application was carried out in accordance with a modified version of Belzona Know-How System Leaflet ENC-8. The area was properly prepared and sealed with Belzona 2221.
