BOW THRUSTER TUNNEL PROTECTED

Vessel in shipyard required resurfacing of bow thruster tunnel before launch. The owner was unaware of the problem prior to the vessel being hauled. Timely response was in order.

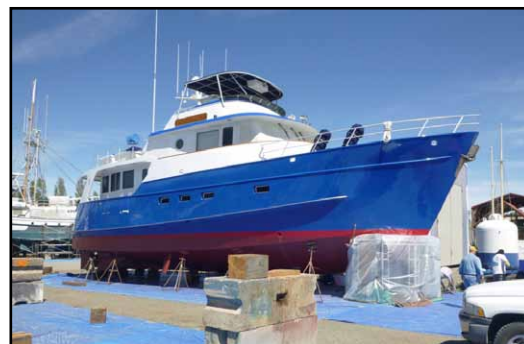
1. Vessel out of water with hutch built around thruster tunnel for containment.
2. Tunnel prepared with abrasive blast. Note significant pitting on upper surfaces.
3. Belzona 1311 applied to pitted areas as seen from inside vessel.
4. Two coat application of Belzona 1321. Bottom paint will be lapped over Belzona 1321 at tunnel edge.

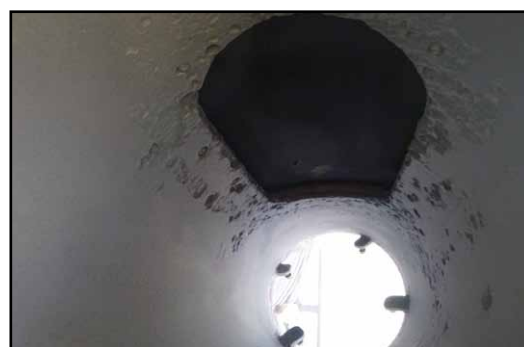
2.

Thruster tunnel was pitted and eroded in areas near thruster propulsion unit. Bi-metallic corrosion was also a component of the deterioration.

Tunnel was prepared by first removing several layers of bottom paint and then abrasive blasting to achieve a 3 mil profile. Belzona 1311 was applied to fill the pitting and erosion prior to the application of 2 coats of Belzona 1321.
