## BELZONA KEEPS WATER OUT AND THE ENVIRONMENT SAFE

**CUSTOMER**  
FPSO, Brazil

**APPLICATION SITUATION**  
Off loading hose damage.

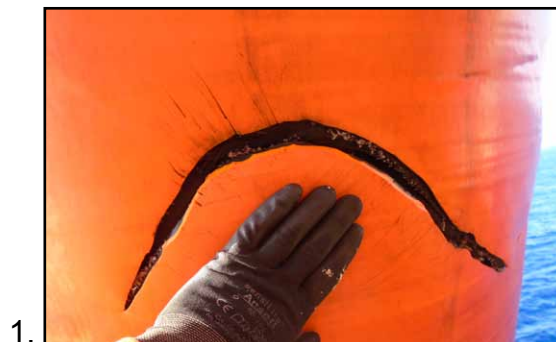
**PROBLEM**  
The crew noticed a tear in the rubber of the off loading hose and took the quick decision to call in the experts to repair it with Belzona.

1. Damaged area
2. Belzona 2911
3. Reinforcement sheet
4. Completed application

**APPLICATION METHOD**  
The application was carried out in accordance with Belzona Know-How System Leaflet SOS-12. The surface was roughened before the application of Belzona 2911, followed by the reinforced system of Belzona 2211 to the damaged areas.
