BELZONA 3411 SOLVES CORROSION PROBLEM FOR NATURAL GAS

Gas Purification Plant, South East of China

A Flange (DN100) on the pipework of a purification unit handling triethylene glycol.

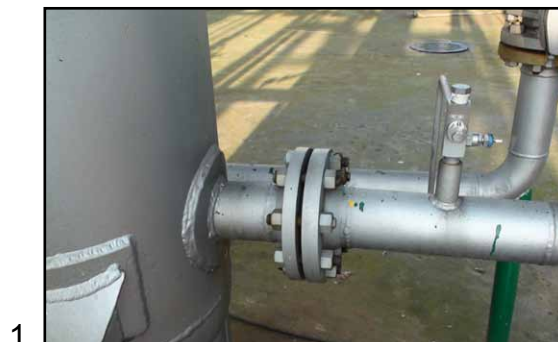
Corrosion around the flanged connections, bolts and welding area.

1. Corroded flange
2. Surface preparation
3. Application of Belzona 3411 by brush
4. Completed application
