BELZONA 1523/1593 HELP COMBAT CORROSION WITHIN AN AMMONIA ACID GAS KOD

CUSTOMER
USA

APPLICATION DATE
January 2014

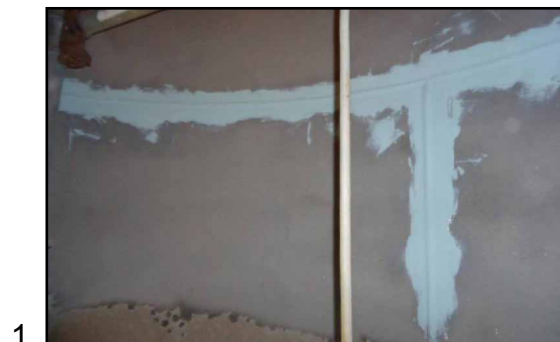
1. The surface was prepared by blasting to SSPC SP-10 Near White Metal
2. Stripe coating of welds and sharp angles with Belzona 1593
3. Application of the 2nd coat of Belzona 1523 in light grey
4. Complete application

The application was carried out in accordance with Belzona Know-How System Leaflet TCC-5. After grit blasting to SSPC-SP 10, the surface was Bresle tested for salt soluble contaminants, cleaned, and degreased with Belzona 9111. Due to high levels of relative humidity, a dehumidifier unit was utilized to prevent flash rusting of the prepared surface, thus avoiding any risk of corrosion prior to coating. Following this, Belzona 1593 hand applied lining was used for stripe coating and nozzle lining. The crew continued with the application of Belzona 1523 using a plural component Graco airless spray system. The coating was applied as a two-coat system with contrasting colors. The application was reported to be a success and the material was found to "spray beautifully". Coating was allowed to cure for inspection. High voltage test was conducted and spotted pinholes were repaired accordingly using Belzona 1593.
