BELZONA REPAIRS AND PROTECTS TURBINE ROTOR

Hydroelectric Power Plant, Brazil

Turbine rotor.

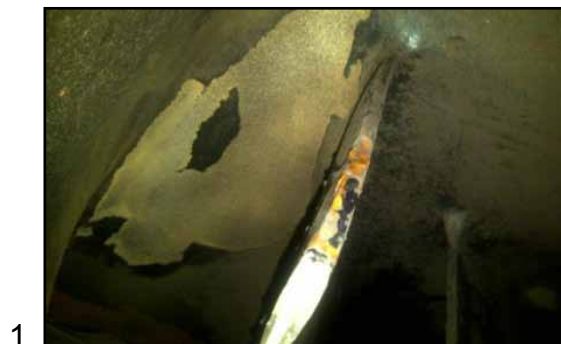
Wear caused by the effects of erosion and cavitation to the rotor with a waterfall height of 110 meters.

1. Worn area of the rotor
2. Defining the application area
3. Application under progress
4. Completed application
