BELZONA SAVES REFINERY FROM DAILY LOSSES OF £1.5M

Petrochemical Refinery, UK

Flare line at refinery.

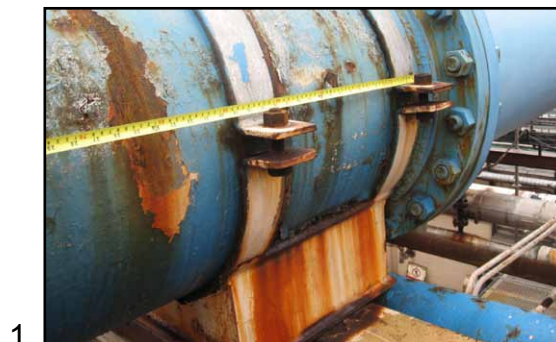
Severe external corrosion had reduced wall thickness. The client required a fast solution to this problem with minimal service disruption. After all, every day of shutdown was costing them £1.5 million.

1. Corroded and pitted pipework
2. Temporary wrap over holed area
3. Application of chemical resistant wrap
4. Final wrap and flange encapsulation
