BELZONA KEEPS RIG RUNNING AFTER GLASS FLAKE FAILURE

A 52" diameter seawater discharge caisson made up of 5 sections of varying lengths (between 11 and 15 meters) on an offshore oil rig required internal corrosion protection.

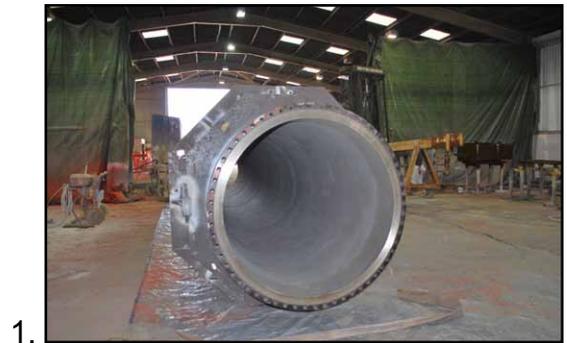
1. Grit blasted caisson
2. Spray application in progress
3. Lining thickness being measured
4. Completed application

The application was carried out in accordance with Belzona Know-How System Leaflet VPF-2. The coating was applied at a thickness of 2 x 1000 microns to optimise longevity of the equipment. Flange faces were protected with Belzona 1111.
