BELZONA NEW GENERATION HIGH TEMPERATURE LINING PROTECTS DESULFURIZATION UNIT

Natural Gas Purification Plant, South East of China

Reboiler in the Desulfurization unit.

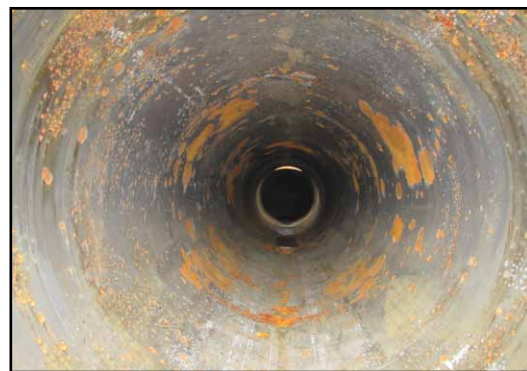
The vessel operates at 150°C (302°F) and 1.6 MPa (232 psi) pressure. The amine media, rich in H₂S, is extremely corrosive, leading to severe pitting and thinning of the vessel wall, thereby increasing operational risks.

1. Interior of the vessel before surface preparation
2. Surface preparation by grit blasting under way
3. Rebuilding pitted areas with Belzona 1511
4. Finished application with 2 coats of Belzona 1593 after inspection

The application was carried out in accordance with Belzona Know-How System Leaflet TCC-5. Belzona 1511 was used to fill the pitted areas and two (2) coats of Belzona 1593 were applied for overall corrosion protection.
