BELZONA REPAIRS OFFLOADING HOSE ABOVE WATER

FPSO, Santos, Brazil

Damaged offloading hose

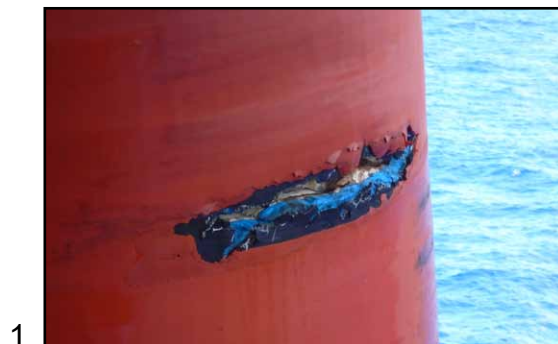
During the normal operation of transfer, staff noticed a small tear in the rubber hose. Three weeks later, the tear had tripled in size and this is when the crew called the experts.

1. View of damaged hose
2. Surface preparation
3. Completed application
4. Overview of the application
