## BELZONA SYSTEM PROTECTS FLANGES AND BOLTS FROM CORROSION

Steel Plant, Taiwan

Fire protection system

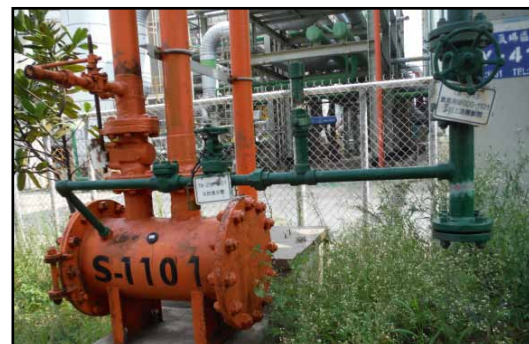
The flanges and bolts were suffering from corrosion problems due to high humidity from the nearby coast.

1. Overview of the fire extinguishing system.
2. Applying Belzona 8411 as a corrosion inhibitor after the surface preparation.
3. Applying Belzona 3411.
4. Completed application.
