BELZONA PROTECTS BRINE SEPARATOR

Oil Company, Canada

2009

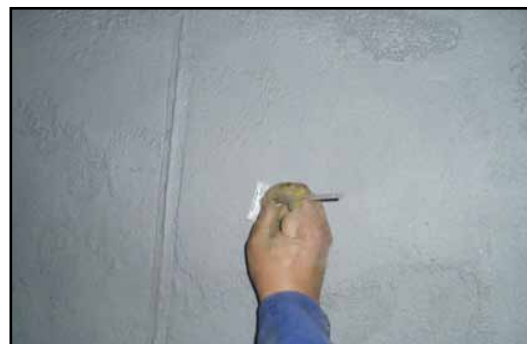
1. Surface after blasting to 3-4mil profile
2. Pitted areas were brush blasted prior to over coating
3. Completed application

The application was carried out in accordance with Belzona Know-How System Leaflet TCC-01. The surface of the vessel was blasted to a 3-4mil profile using aluminum oxide blasting grit. The pitted areas of the vessel were rebuilt with Belzona 1511, a high temperature rebuilding compound specifically formulated for these types of applications. The rebuilt areas were brush blasted prior to over coating. After strip coating all internal weld areas and outer edges, complete vessel and man cover were protected with Belzona 1521.
