BELZONA REPAIRS A BULLET HOLE ON A MEMORIAL

Seattle, WA, USA

City park memorial statue.

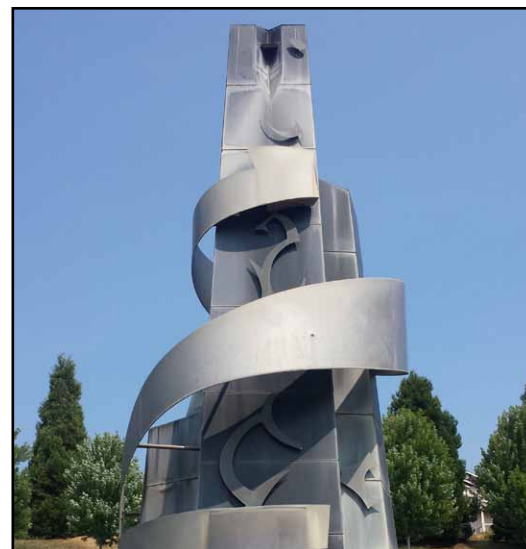
Someone had fired a bullet at the statue. The bullet struck the metal band from behind resulting in a mushrooming effect out of the face. This statue has water running over the front of it and because of the metal being pushed out from the bullet it was beginning to streak and stain causing discoloration of the metal.

1. The statue with the bullet hole visible.
2. The bullet hole up close / The bullet hole prepped.
3. The completed repair. Front / Back.
4. The repair from 40' away, virtually invisible.

The damaged metal was ground down leaving a rough and slightly concave area. The Belzona 4111 resins were mixed and used to condition the surface. The Belzona 4111 aggregate was then added to the resins until it was of a thick and "dry" consistency. A piece of tape was mounted to the back after applying a layer of Belzona 4111 to hold the Belzona 4111 in place until it cured. The front surface was then packed full and tight, then the excess was carefully removed, and the remaining Belzona 4111 smoothed off.
