## BELZONA PROTECTS TAIL SHAFT ON A US NAVY SHIP

Tail Shaft of U.S. Navy Ship.

The US Navy required superior protection against erosion and corrosion in the transition area of shaft coatings.

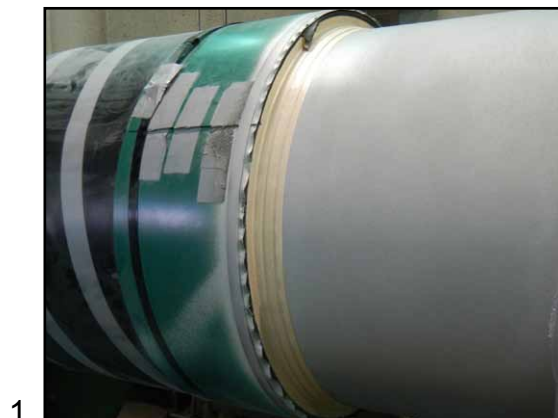
1. Tail shaft after grit blasting
2. Chloride test
3. Tail shaft with Belzona 2941
4. Completed shaft coating

The application was carried out in accordance with Belzona Know-How System Leaflet SOS-2. The shaft was grit blasted to an SSPC-SP10 finish and then coated with Belzona 2941. The shaft areas were then coated with Belzona 2141 and finally with a fiberglass coating.
