BELZONA PROTECTS STERN TUBE (BEARING AREA) ON A US NAVY SHIP

Stern Tube on a U.S. Navy Ship

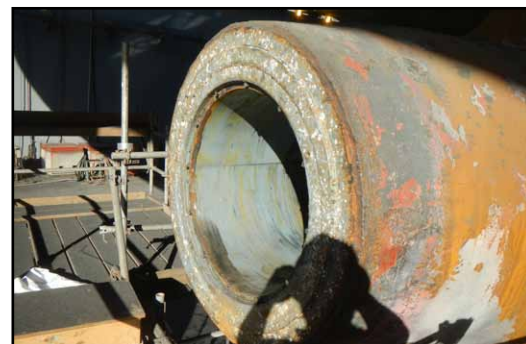
1. Stern tube of the ship after tail shaft removed
2. Inspection after grit blasting
3. First coat of Belzona 1341
4. Completed application

The stern tube was grit blasted to an SSPC-SP10 and then the damaged areas were filled with Belzona 1111. Belzona 1341 was then brushed on and followed with a roller to maintain a consistent run-out tolerance.
