BELZONA RESCUES A 100-YEAR OLD PENSTOCK

Hydropower, Northeastern USA

Steelwork of 10 foot diameter penstocks in a Hydropower plant.

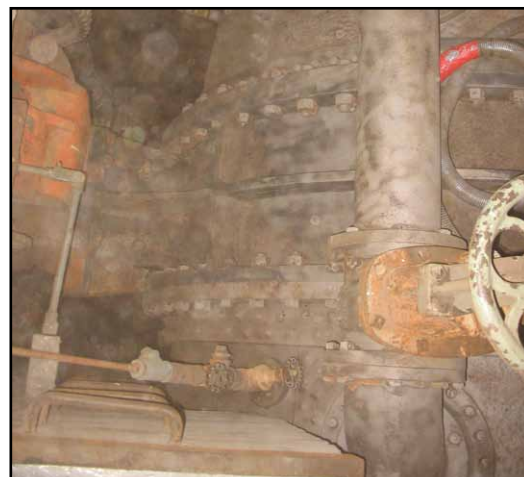
1. Penstock embedded in concrete thrust block at base of the dam
2. Pinholes discovered during the work
3. Surface prepared by blasting
4. Completed application

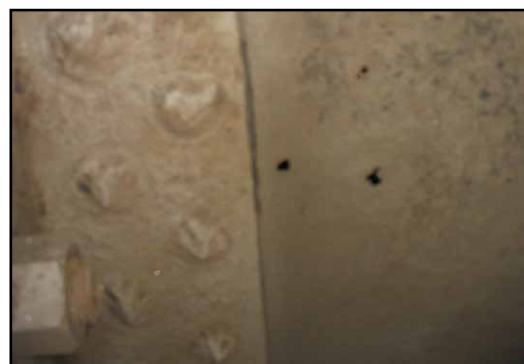
2.

100 plus year old steelwork was corroding from moisture. The problem was detected when installing new control valves and trash racks on penstocks.

The plant was originally built in 1908 and the original steelwork showed significant exterior corrosion, thus operators feared that it would soon have pinholes. The plant was shut down for control upgrades so operators chose Belzona because of its reputation in similar situations.

The surface was properly prepared by abrasive blasting. First, the pits and holes were repaired with Belzona 1121 and then overcoated with Belzona 5811.
