BELZONA KEEPS WIND TURBINES SPINNING

Wind Farm, Teesside, UK

27 offshore wind turbines. Each turbine has between one and three hang-off flanges.

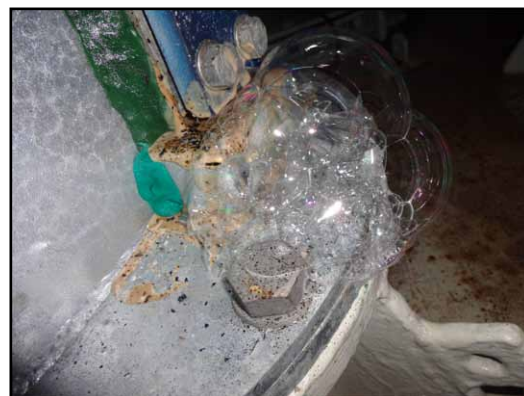
Many of the flanges were not gas tight. Changes in tide led to dangerous gases seeping from the seabed and into the chamber. A temporary sealant had been applied but could not effectively seal the leaks and a permanent solution was required.

1. View of the wind farm
2. Leaking flange
3. Second leaking flange
4. Belzona solution applied

Belzona Technosol, Belzona's UK application division, was signed on to carry out the repairs with the application in accordance with Belzona Know-How System Leaflet VPF-11. After removing the temporary repairs and preparing the surfaces, Belzona 1161 was used to pack the joint and seal the nuts and bolts using caps filled with product. Two coats of Belzona 5831 were applied onto the flange tops and bottoms to ensure a lasting protection and to eliminate any risk of leaks.
