BELZONA REBUILDS OVERSIZED HOUSING

Dockyard, Croatia

November, 2015

Stern tube of ship.

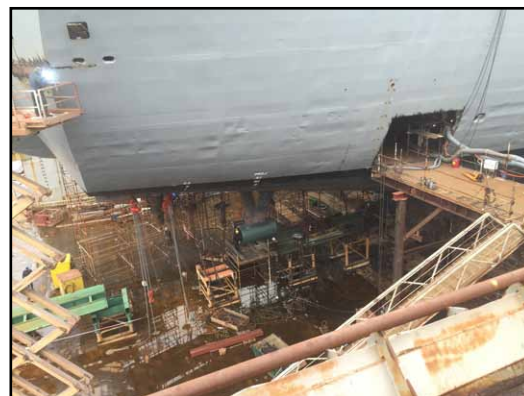
1. General view of ship in drydock
2. Prepared surfaces
3. Machining down to profile
4. Completed application
