BELZONA COATS A SHOWER FLOOR AND PREVENTS MAJOR WATER ISSUES

Army Base, Oklahoma

Communal shower floors at an Army Base

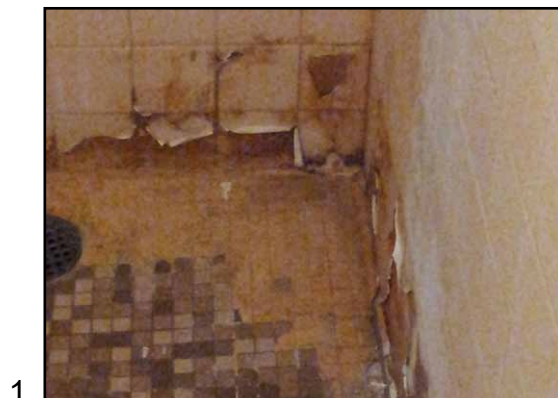
Remove existing coating. Seal Floor from leaking water. Repair damaged tiles, and missing tiles. Provide a non-slip surface. Make cosmetically appealing. Ensure easy cleaning. Provide lasting wear-resistance and protection from further damage. The grout between the tiles has been removed over time due to heavy cleaning with bristle brushes, therefore allowing water to bleed through the walls and onto the public walkways, causing a slip hazard and water damage to the dividing walls. After several attempts of regrouting, the customer tried installing a truck liner product to seal the floor. Shortly thereafter, the coating peeled off and created a cosmetic mess and made it difficult to clean. When trying to remove the failed truck liner, several tiles broke and cracked, causing more water issues.

1. Existing Conditions
2. Grouting with Belzona 4111
3. First coat of Belzona 5811 encapsulated with Belzona 9221
4. Application completed with a second coat of Belzona 5811
