BELZONA REPAIRS AND PROTECTS SEA WATER CIRCULATION PUMP

Power plant, Fujian, China

The casing of sea water circulation pump

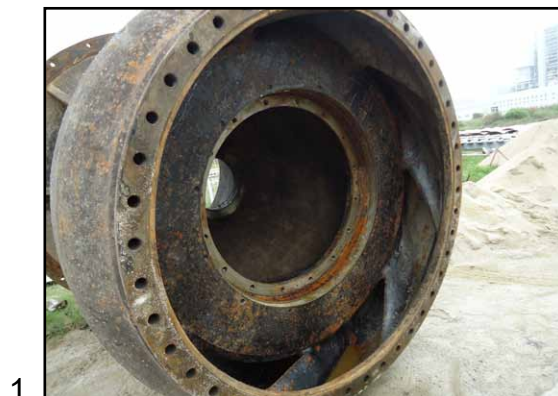
After years of operation, the casing was badly eroded and damaged by the sea water

1. Overview of the circulation pump
2. Surface preparation by grit blasting
3. Close-up view of the damaged area after the blasting
4. Completed application
