BELZONA 7111 PROVIDES ALIGNMENT TO MAIN ENGINE ON BOAT

Main engine base of the propulsion system on the fishing boat.

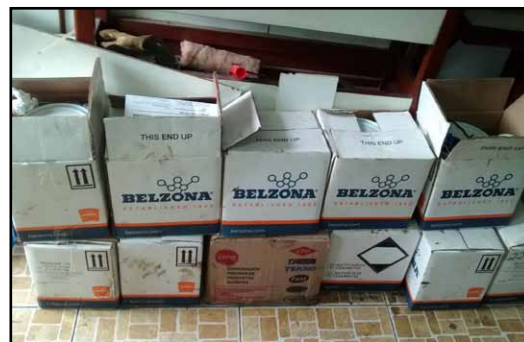
1. Belzona 7111 on board
2. Chock at engine base
3. Detail of casing before pouring
4. Verifying the correct engine-gearbox alignment
