## BELZONA REPAIRS FLOOR CRACKS CAUSED BY A ZAMBONI

Floor leading to rink access used by a Zamboni.

Cracks and pitting caused by studded tyres of a Zamboni.

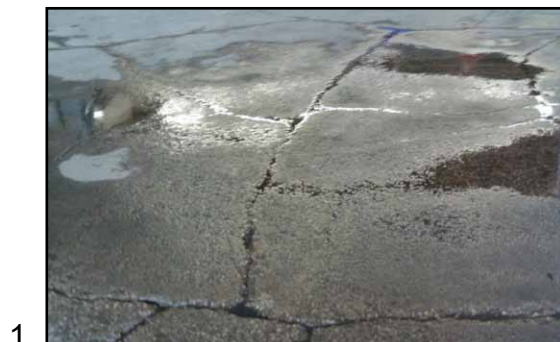
1. Prior to application
2. Surface preparation in progress
3. Application in progress
4. Completed application
