## BELZONA REPAIRS HOLE ON SCUM TANK

Scum tank at a water pollution control plant.

Hole caused by corrosion.

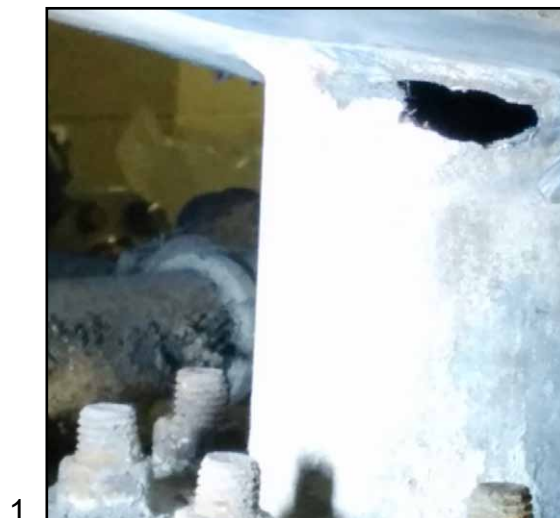
1. Prior to application
2. Preparation in progress
3. Application in progress
4. Completed application
