BELZONA PROTECTS NEW FLANGES AGAINST CORROSION

Well head flanges.

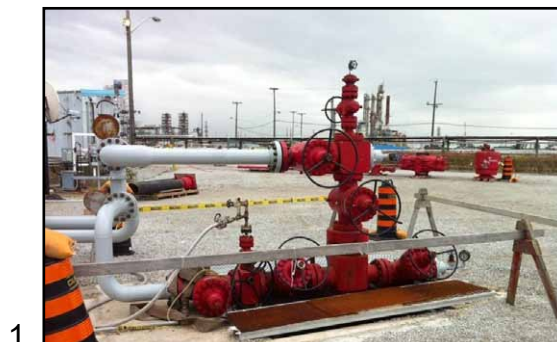
Previous flanges were suffering from corrosion. New flanges were installed and the customer wanted to avoid corrosion.

1. Prior to application
2. Completed application
3. Completed application

The application was carried out in accordance with Belzona Know-How System Leaflet GSS-11 for the protection of flanges and fastenings. The surface was cleaned and prepared using Belzona 9111 to remove all dirt, grease and surface contaminants. The surface where Belzona 3411 was bonded to was prepared using a wire brush. Belzona 9431 was applied to the flange, covering the gap. Belzona 8411 was spray applied to the surface and once touch dry, plastic caps were applied to the bolts of the flange. Two coats of Belzona 3411 were applied to the flanges in accordance with Belzona Instructions For Use.
