BELZONA PROTECTS HELLAN FLUID STRAINER FROM WASTE

A Hellan fluid strainer at a Water Pollution Control Plant.

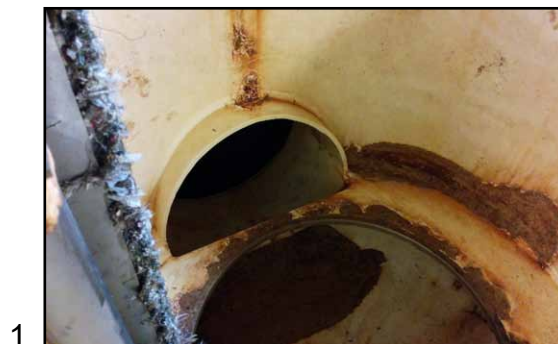
Erosion/Corrosion from the waste water.

1. Prior to application
2. Preparation of the surface
3. Completed application
4. Completed application

The application was carried out in accordance with Belzona Know-How System Leaflet CEP-5 for the repair of general erosion damage. The surface was blasted to prepare the area. Belzona 1212 was applied to build up any areas that were pitting. As a two coat system, Belzona 1331 was brush applied to the surface in accordance with Belzona Instructions For Use.
