BELZONA SEALS CEILING IN CHICKEN PLANT

Ceiling joints at the Chicken plant

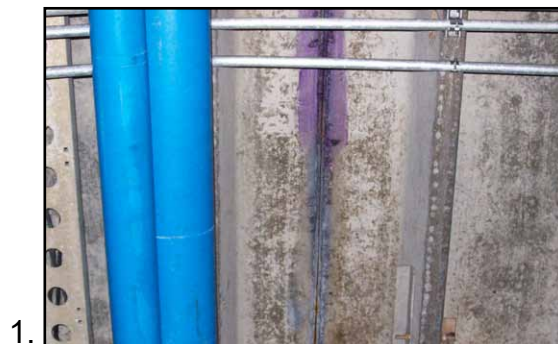
Carbon steel metal that is between the concrete prefabricated roof is rusting. The rust is falling onto the chickens and workers as they are being processed. The FDA came in and made them do a repair for the problem.

1. View of the joint with metal and concrete
2. Application of Belzona 3911
3. Applying Belzona 3111
4. Completed application
