BELZONA USED FOR EMERGENCY BOW THRUSTER REPAIR

Bow thruster

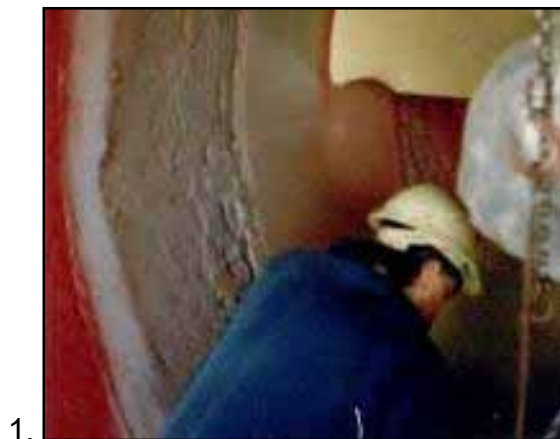
1. Preparation of bow thruster underway with a check on actual metal thickness.
2. Close up showing extent of problem.
3. Completed application.

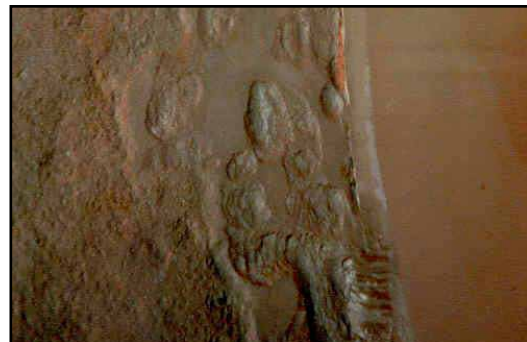
2.

Bow thruster insert was suffering from major corrosion-erosion problems.
