BELZONA REPAIRS AND PROTECTS ERODED TUG BOAT KORT NOZZLES

Eroded tug boat kort nozzles

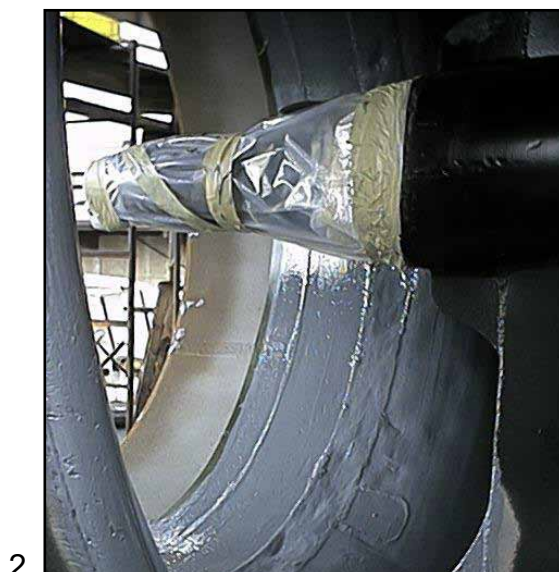
Bi-metallic corrosion had eroded much of the metal and welds adjoining the stainless steel insert positioned in the center of the nozzle.

1. View of vessel in dry dock
2. Repairs to eroded and damaged areas in progress
3. Completed application

The application was carried out in accordance with Belzona Know-How System Leaflets SOS-1 & SOS-2.

Tugs used for hauling log booms up and down the coastline. Original application had taken place in 1996. Sections of the kort nozzle had to be replaced because of excessive internal corrosion. Much of the original coating and rebuilt areas were still in good condition. The owner was happy to reapply Belzona once the new sections were in place and welding complete. Rebuilding the nozzles with Belzona 1311 eliminates excessive welding. Coating the repaired area with Belzona 1321 improves the abrasion resistance of the surfaces and eliminates bi-metallic corrosion.
