BELZONA REBUILDS ERODED RUDDER PINTLE HOUSING

Eroded rudder pintle housing

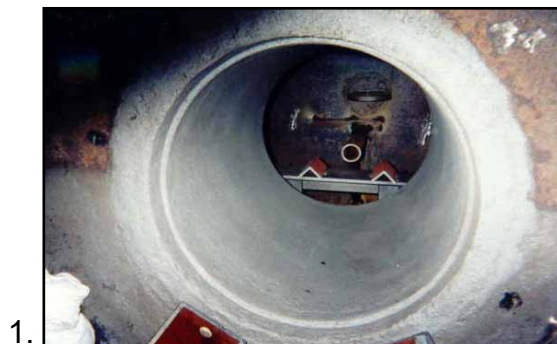
Bi-metallic corrosion had eroded much of the metal (about 1/4 inch) from the rudder pintle housing.

1. View of blasted rudder housing.
2. Housing coated with Belzona 1321 to increase slip factor.
3. Rudder in position on horizontal slide partially inserted.
4. Rudder pintle inserted and allowed to set up before being removed with the aid of a 30 ton hydraulic jack. The reformed bore was inspected by the ships insurers and found to provide almost 100% contact.
