REPAIR & PROTECTION OF CHILLER WITH BELZONA

Office Building, Jakarta, Indonesia

End Cover and Tube Sheet of Trane Chiller from an office building Air Conditioning Unit

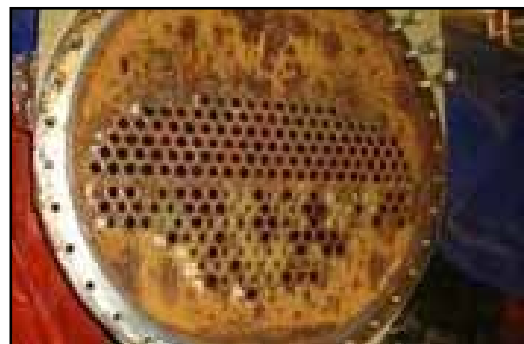
1. Corroded area on Tube Sheet surface
2. Belzona 1321 being applied to chiller end cover
3. Pitted surface of tube sheet being rebuilt with Belzona 1321
4. Removing excess Belzona 1321 after applying two coats to the tube sheet.
