BELZONA SEALS VALVE LEAK AT DESALINATION PLANT

Desalination Plant, Australia

September 2010

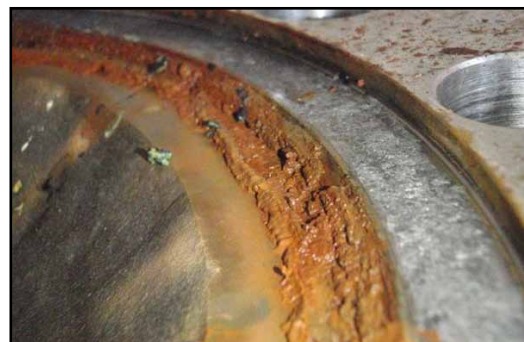
The sealing faces of the plug and seat valves corroded and were leaking due to galvanic and crevice corrosion.

1. 1. Damage caused by crevice and galvanic corrosion
2. 2. Grit blasted top face and plug
3. and 4. Finished repair with Belzona 1111 applied
