## BELZONA PROTECTS VIBRATORY SCREENING MACHINE

Building materials factory, Croatia

February 2016

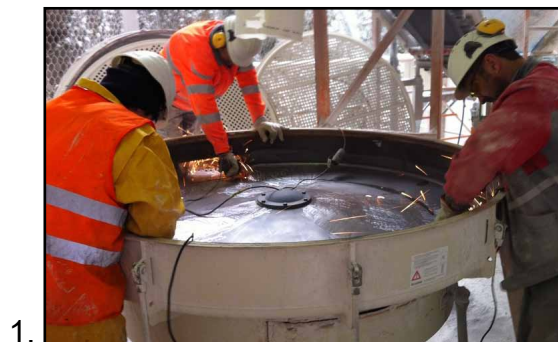
1. Surface preparation in progress
2. Surface prepared
3. Application completed
