## BELZONA SEALS NEW PIPES IN HOTEL WATER RESERVOIR

New piping of a hotel water reservoir

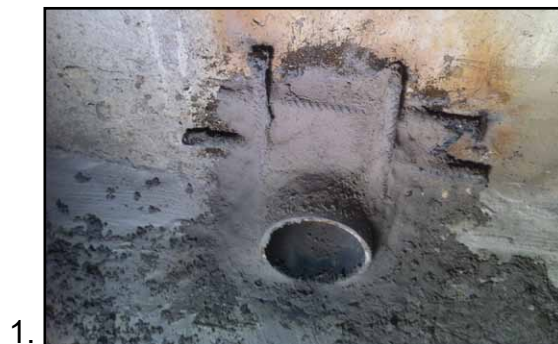
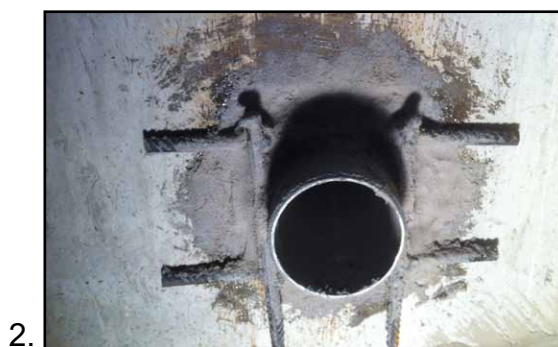
1. & 2. Internal application to secure new pipes
2. & 4 External fixing of pipes

New pipes drilled into the water reservoir needed to be anchored and sealed to the tank wall.

The costumer was looking for a reliable solution since all the previous repairs resulted in leaks around the pipes. Belzona 4111 provides high bond strength without shrinking enabling a secure leak free installation.
