## BELZONA ELIMINATES TRIP HAZARD FROM DRAIN COVERS

Shopping centre, Bankstown, Australia

Drain covers in various areas of shopping centre.

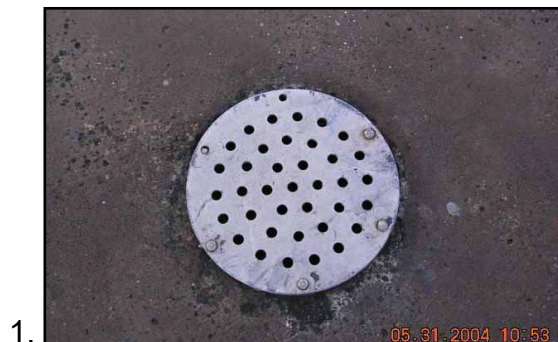
Existing drain covers were proud of surface creating a potential trip hazard.

1. The raised drain plate
2. Belzona 4111 to rebuild drain
3. The plate fixed in place
4. Coated with Belzona 4411
