BELZONA SQUARES THE CORNER

Shopping centre, Brisbane, Australia

Damaged wall at a local shopping centre

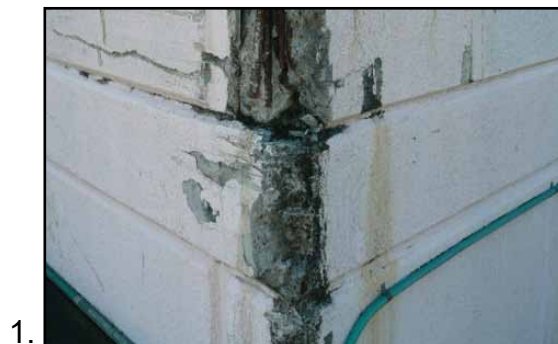
A delivery truck had reversed into the wall of the shopping centre, damaging the wall and exposing the reinforcement.

1. Close up of the original damage
2. Crack stabilisation complete
3. Rebuild of the damage underway
4. The completed application
