## DAMAGED CONCRETE IN COLD ROOM REPAIRED WITH BELZONA

Food processing plant, Brisbane, Queensland, Australia

Cold room Floor

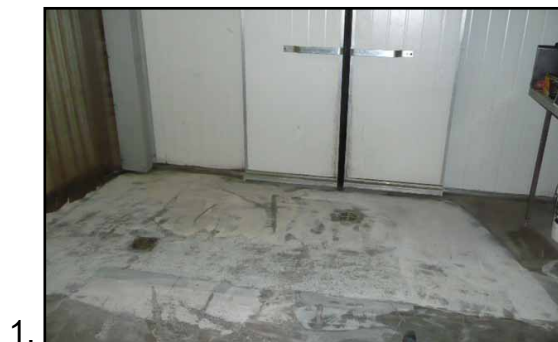
The concrete around the entrance to the cold room had degraded and was causing access issues for pallet trucks. Previous attempts using proprietary repair products had also failed

1. The damaged floor
2. Close up of the damaged floor
3. Repairs underway
4. Repairs completed

Application was carried out in accordance with Belzona System Leaflet FPA-1. The damaged concrete was removed back to a sound substrate before being rebuilt using the Belzona 4111 system which was feathered out to match up with the existing floor to provide a smooth level surface allowing easy access to the cold store
