## BELZONA REPAIRS CONCRETE AFTER BOLLARD REMOVAL

Shopping Centre, Bankstown, Australia

Damaged concrete in 48 areas where bollards were removed

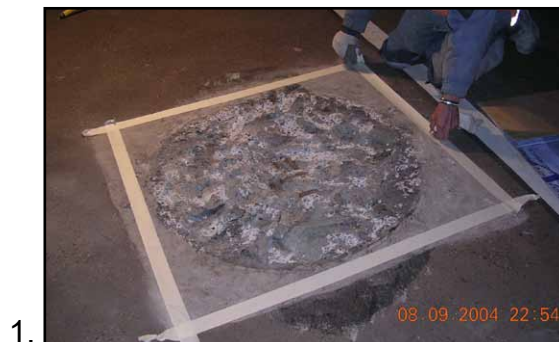
Removal of bollards left rough concrete substrate that was a trip hazard.

1. Damaged concrete
2. Conditioner applied
3. Mixing Belzona 4111
4. Applying Belzona 4111
