BELZONA WATERPROOFS HIGH RISE BUILDING

Office block, Brisbane, Queensland, Australia

Flat roof on a city centre high rise office block.

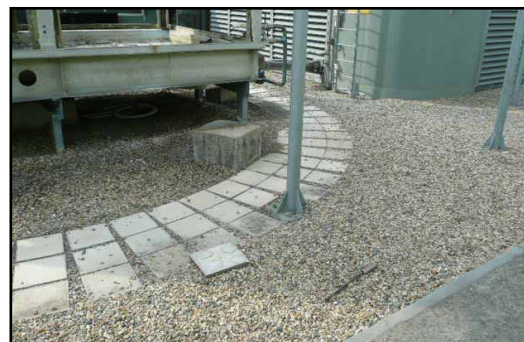
The existing roofing system had failed allowing water to leak into the offices below.

1. The roof before application showing the stone covering
2. Roof stripped and ready to coat
3. 1st coat of reinforced Belzona 3111 applied
4. The finished application

Application was carried out in accordance with Belzona System Leaflet RPA-1. Before application could commence the decorative stones had to be removed. Further inspection revealed that the existing roof membrane had perished and the decision was made to reseal the entire roof including the concrete walkways. The roof was stripped and cleaned before being over-coated with a fully reinforced Belzona 3111 system.
