## BELZONA REPAIRS CAR PARK RAMP

Shopping centre, Bankstown, Australia

Car park access ramp.

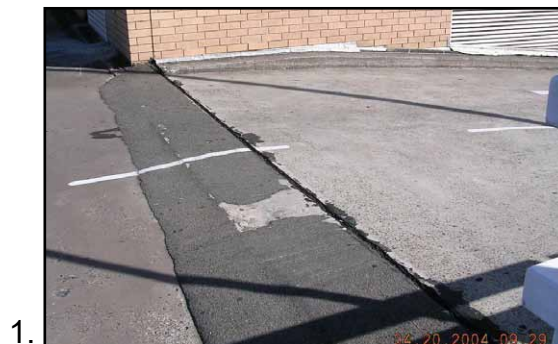
Existing ramp concrete surface was badly damaged and expansion joint between the concrete slabs had deteriorated.

1. The damaged ramp
2. Applying Belzona 4111 to the ramp
3. Pouring Belzona 2221 to seal the expansion joint
4. The completed ramp and expansion joint

Application was carried out in accordance with the Belzona Know-How System leaflets FPA-1 and FPA-6. Existing ramp was removed by jackhammering and grinding and replaced with Belzona 4111. Existing expansion joint seal was removed and replaced with Belzona 2221 Elastomer.
