BELZONA REPAIRS SHOPPING CENTRE EXPANSION JOINT

Shopping centre, Campbelltown, Australia

Damaged expansion joint in shopping centre main entrance.

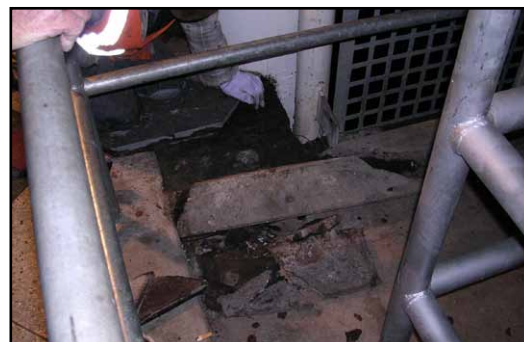
1.

The concrete floor and joint nosings were badly damaged and the expansion joint was disbonding from the edges allowing water to leak to the lower level. As joint was in the main entrance to the shopping centre, it presented a serious trip hazard.
