BELZONA PROTECTS NEW GLYCOL TANK

Steel fabrication company, Scotland, UK

A newly fabricated tank for an industrial refrigeration system was in need of corrosion protection.

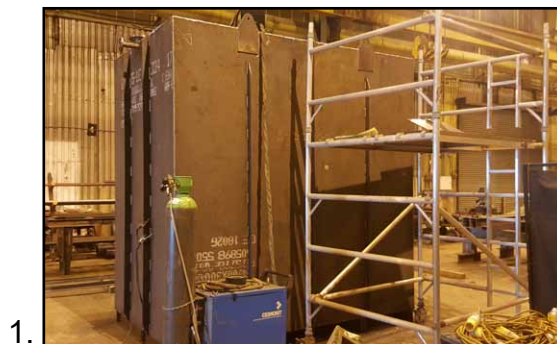
1. Newly fabricated tank
2. Tank onsite, laid on its side
3. Coating underway
4. Completed application
