BELZONA PROTECTS ACID BUND AT CHEMICAL PLANT

Chemical plant, Kwinana, Western Australia

Tanker loading/unloading station for 98% Sulphuric Acid.

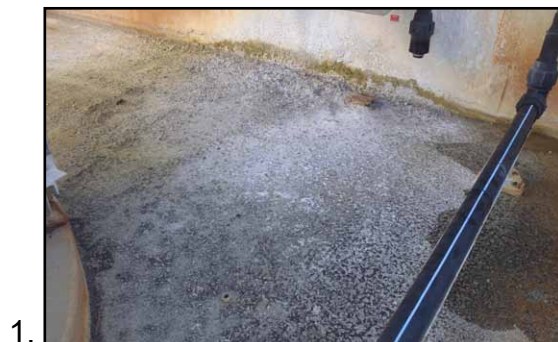
The concrete floor of the bund had been damaged by leaks during tanker deliveries.

1. Original condition of concrete before repair
2. Another view of the damage
3. Completed application
4. Another view of the completed application

Application was carried out in accordance with Belzona System Leaflet TCC-15. The floor of the bund was first washed to neutralise any remaining acid contamination before being abrasive blasted. Belzona 4111 used to rebuild damaged concrete before applying two coat system of Belzona 4311. Aggregate was applied to top surface whilst wet to create a non-slip surface.
