BELZONA SAFETY FLOORING AROUND MIXER

Ceramics producer, Gliwice, Poland

May 2011

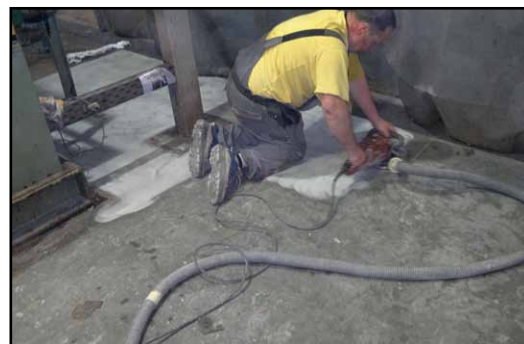
1. Grinding concrete floor
2. Repair of damage and filling cavities with Belzona 4111
3. Application of Belzona 4411
4. General view of the floor after application of Belzona 4411 system

The application was carried out in accordance with Belzona System Leaflet FPA-8. After removing rubber sheets and cleaning the concrete, Belzona 4111 was used to level the concrete before applying the Belzona 4411 non-slip system.
