BELZONA PROTECTS NEW VACUUM PUMPS

Paper Machine Manufacturer, France

New vacuum pumps at paper machine manufacturer in need of erosion and corrosion protection.

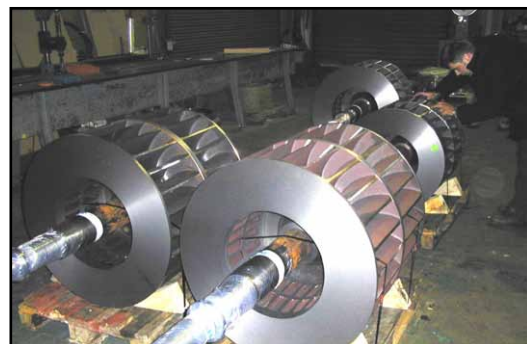
1. New rotors
2. Protected pumps
3. Application on a rotor
