## BELZONA CURES DRUG FACTORY FLOOR

Pharmaceutical company, Warsaw, Poland

June 2013

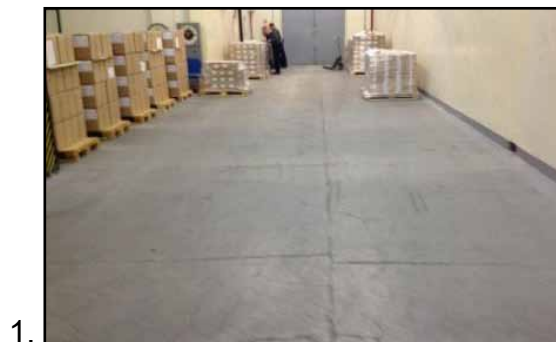
Very damaged and cracked concrete floor in the medicines factory.

The cracks collect a lot of bacteria and contaminants creating a serious hygiene issue.

1. View of damaged warehouse floor
2. Close up of the cracked concrete
3. & 4. The floor after application of Belzona 5811

Application was carried out in accordance with Belzona System Leaflets FPA-1 and FPA-3.

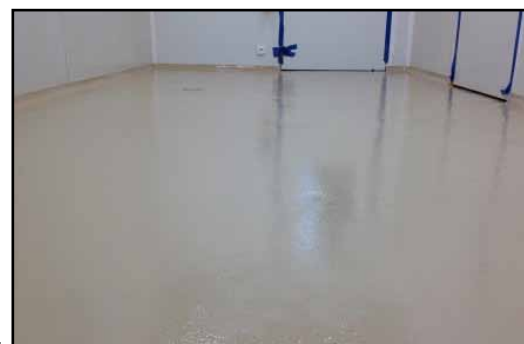
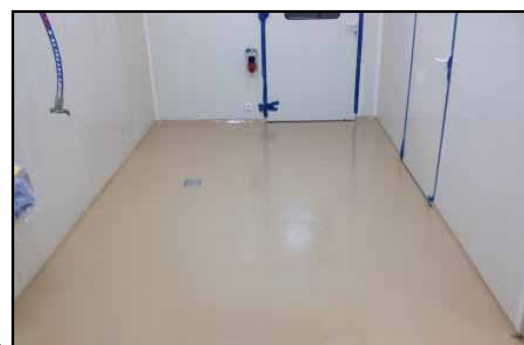
3.

Belzona system enabled floor repairs to be carried out with minimal disruption to production in adjoining areas. Belzona repair provided a smooth, easy-to-clean, hygienic surface suitable for pharmaceutical production.

Belzona 4111 (Magma Quartz)

Belzona 5811 (immersion Grade)
